Nickel-Chromium-Molybdenum Superalloys: The Solution to Corrosion Problems in Wet Limestone FGD Air Pollution Control Systems

Lewis E. Shoemaker and James R. Crum
Special Metals Corporation, Huntington, WV USA

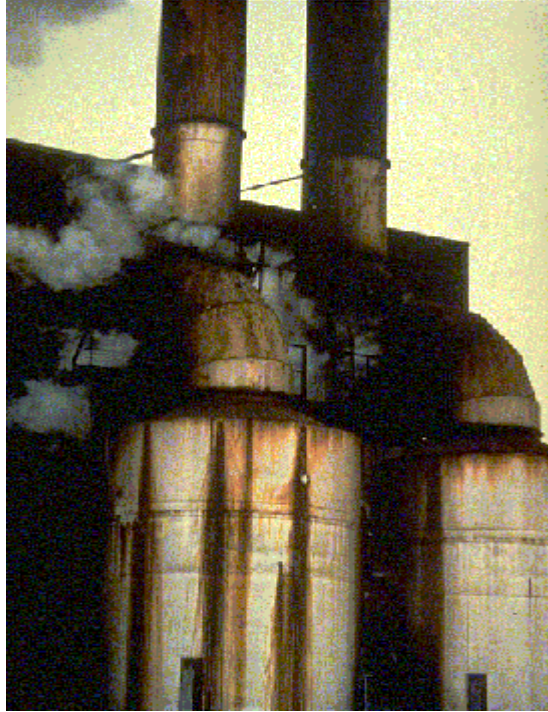
Figure 1

Failure of an organic coating led to perforation of a steel vessel by corrosion after only 6 months of operation at the Louisville Gas & Electric Company Cane Run Station in Louisville, KY. The use of corrosion-resistant superalloys has essentially eliminated such failures in modern FGD systems.

having the lowest initial cost (i.e. unlined steel or structural steel covered with organic linings). It was generally assumed that the FGD environments would not be excessively corrosive. This perception was, unfortunately, proved to be far from accurate when FGD equipment began to show premature failure, poor reliability, high maintenance costs, and forced shutdowns for repair of corroded components. Corrosion, erosion, and poor lining installation, particularly in outlet ducting and stack liners, caused significant problems for utilities (Figure 1).

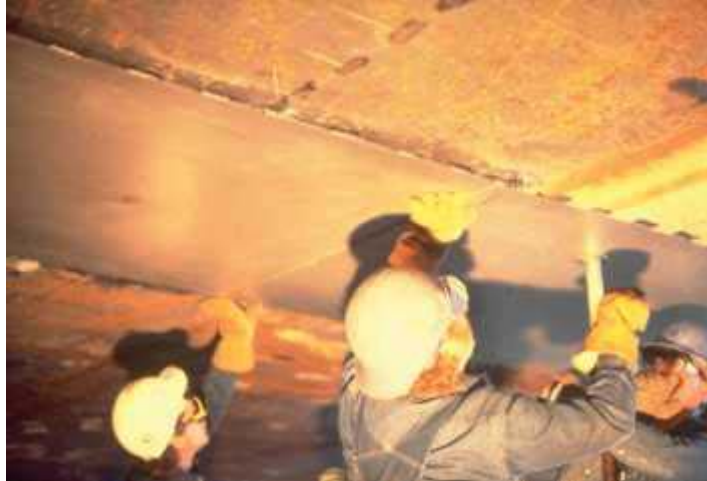
Figure 5

Installation of 1/8" (3.2 mm) INCONEL alloy 622 sheet by the wallpaper technique at the Virginia Electric Power Company Mt. Storm Station in Davis, WV. Intermittent ("skip") weldments are used to attach the alloy sheets to the steel substrate. The next sheet to be installed will overlap this sheet by 1 to 2 inches. Thus, the seal weld which will be exposed to the service environment will not be diluted with iron from the steel structure.

Wallpaper cladding is accomplished by welding thin alloy sheet, usually 1/16 in. (1.6 mm) or 1/8 in. (3.2 mm) in thickness, to a structural steel substrate (Figure 4). The sheet is attached by means of intermittent welds between the alloy sheet and the structural steel (Figure 5). Thus, the attachment welds are diluted with iron from the steel structure. A second sheet overlaps the edge of the previous sheet to protect the diluted structural welds. A solid weldment is then used to join the two sheets. Thus, the weldment which will be exposed to the service media is not diluted with iron but is fully resistant. Capped plug welds are used to stiffen the sheet cladding (Figure 6).

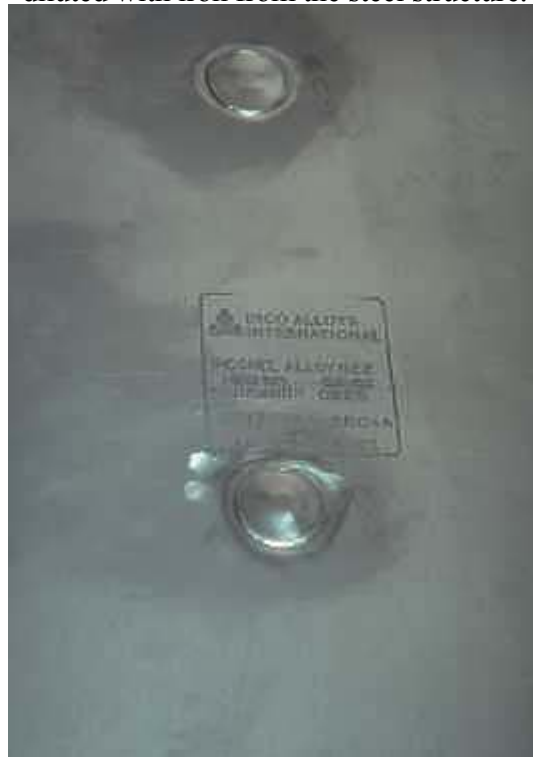
Figure 6

A close-up view of a section of INCONEL alloy 622 wallpaper at the Virginia Electric Power Company Mt. Storm Station. Note that the plug welds are covered with protective caps of the same alloy. Here as above the service welds are full alloy with no iron dilution.

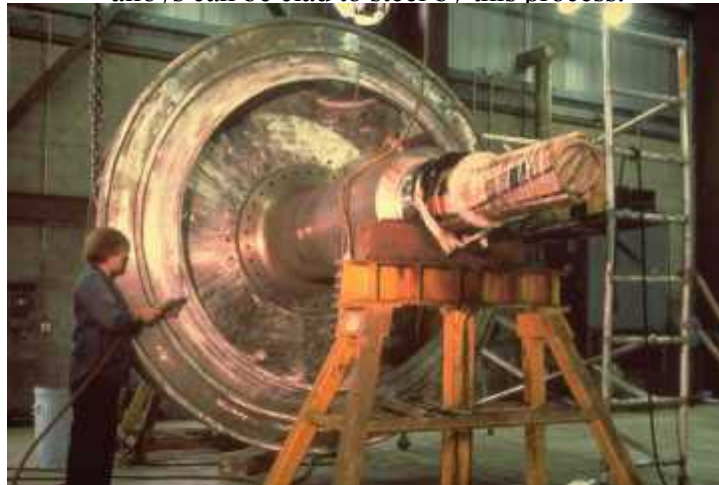
Figure 12

An induced draft fan fabricated from INCONEL alloy 625 plate. Fans are used to force the wet scrubbed gases through the scrubbing system and up the chimney when natural draft is insufficient. Because of its high tensile and fatigue strength along with its excellent corrosion-resistance, alloy 625 is the material of choice for such components.

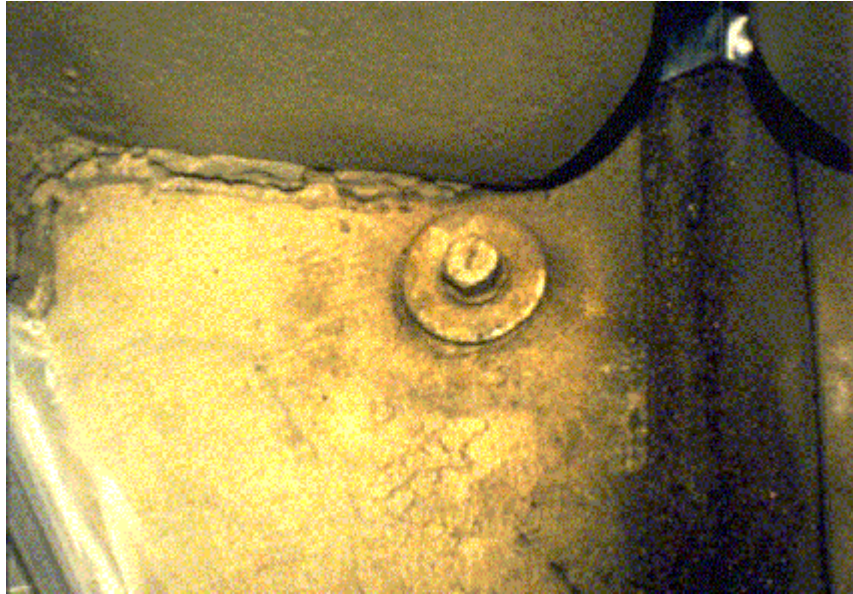
Figure 13

Severe corrosion of an alloy C-276 weldment and alloy C-276 plate in the by-pass duct at the Seminole Electric Cooperative Station in Palatka, FL. This is one of the few occurrences of rapid corrosion of alloy C-276 under FGD conditions.

Shortly after its commercial introduction, INCONEL alloy 686 was employed to solve a major corrosion problem at the Seminole Electric Cooperative Power station in Palatka, Florida, USA. The alloy C-276 lining in a by-pass duct was being rapidly attacked by a corrosive media that was condensing on the walls and standing on the floor. Alloy C-276 plate was corroding at the excessively high rate of 40 mpy. However, alloy C-276 weldments had been essentially corroded away due to the effects of elemental segregation (Figure 13). These welds were replaced by

To determine why the alloy C-276 lining was corroding at such a high rate, the condensate inside the duct was analyzed. It was found to contain 127,000 ppm chlorides, 2,900 ppm fluorides, and 180,200 ppm sulfates at a pH of 0.8 ! Thus, it is not surprising that alloy C-276 corroded under these conditions. What is most important, however, is that alloy 686 products, even segregated weldments, were able to resist this environment.
